Special Report 77-2

CRREL ROOF MOISTURE SURVEY

Pease AFB

Buildings 33, 116, 122 and 205

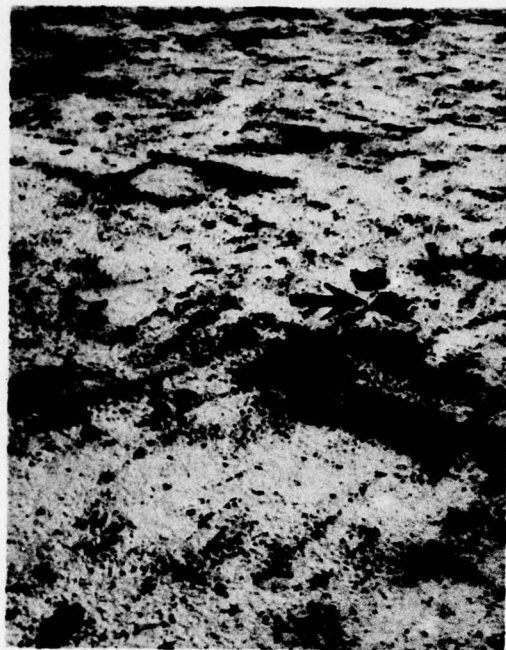
As shown in Figure 1, the surface of the aluminized roof is uneven and discolored. Surface texture differences are even more pronounced on the southerly portion of the roof where both aluminized and non-aluminized coatings have been applied. The thermal image of the roof is also confused, as shown in the Figure 2 thermogram. The light-colored

Figure 1. Daytime photograph of a portion of the northerly roof, Building 33. The arrow points to the location of sample A.

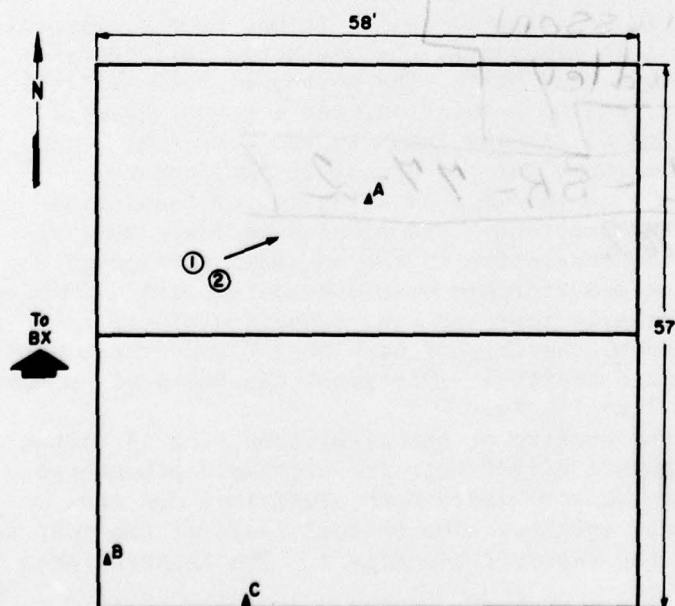
Figure 3. Plan view of Building 33. The water content of the insulation at sample A was 2%. Samples B and C were taken by WES in 1975. The WES samples indicate that some moisture may have entered the insulation in the southern portion of the roof. The arrow indicates the viewing direction and location of subjects in Figures 1 and 2.

areas on the thermogram could represent areas of wet insulation on a normal gravel-covered roof. However, the varying emissivity of the discolored aluminized coating on this roof is believed responsible for the blotchy nature of the roof's thermal image. Sample A, taken on this roof where shown in Figure 3, showed the insulation to be essentially dry. Its water content was 2%.*

It is understood that leaks persist. Based on a visual examination of the flashings and the fact that no large wet anomalies were detected by the infrared camera, it is felt that the leaks are probably associated with the flashings. It may be possible to resolve these leaks by careful examination and patching of the flashings. However, if such maintenance fails to stop the leaks, the membrane and insulation should be removed and replaced over the entire roof.

Although the patched and overcoated roof of *Building 33* is visually in poor shape, the insulation appears to be dry over most of the roof. The leaks are probably associated with flashing flaws. Perhaps another attempt should be made to prevent leaks, but this time flashing repairs should be made rather than flood-coating the entire roof. If leaks persist, all the insulation and built-up membrane on this small roof should be removed and replaced.

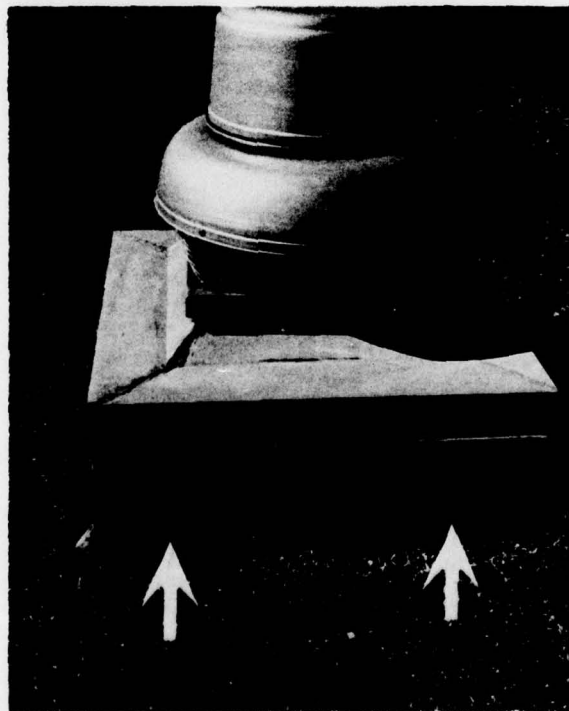
Although there have been no significant problems with the roof of this building, past visual examinations by the base Civil Engineering Division and CRREL indicate that the membrane has a few blisters, felts are exposed along the perimeter, flashings need repair (Fig. 4), and two large membrane buckles are present.

Figure 4. Arrows point to flaws in a vent flashing, Building 116.

Although no wet insulation was detected with the infrared camera, the roof is deteriorating. Steps should be taken to correct the above-mentioned roof deficiencies before water finds its way into the insulation, necessitating expensive repairs.

The roof of *Building 116* is in fairly good condition. It does not need replacement, but comprehensive repair of flashings is required to prevent rapid deterioration.

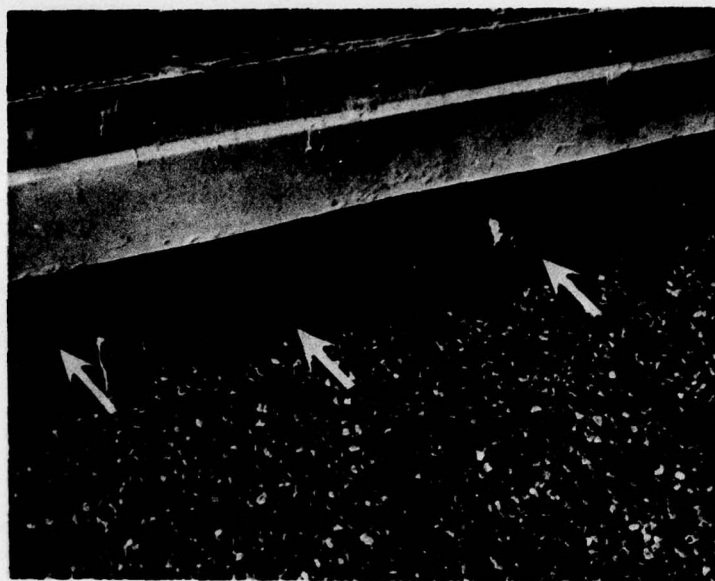
Figure 5. Arrows point to flashing flaws at the firewall, Building 116.

The main roof is subdivided by a masonry firewall. The firewall flashing is split in several places, as shown in Figure 5. A plan view of this roof is shown in Figure 6. The main roof consists of a gypsum deck, $1\frac{1}{2}$ in. of glass fiber insulation, and a gravel-covered built-up membrane about $\frac{3}{8}$ in. thick. A ridge runs the long dimension of the main roof at its centerline. From the ridge the roof slopes noticeably to its eaves. Internal drains are located near the eaves. The smaller roofs are lower than the main roof and are essentially flat.

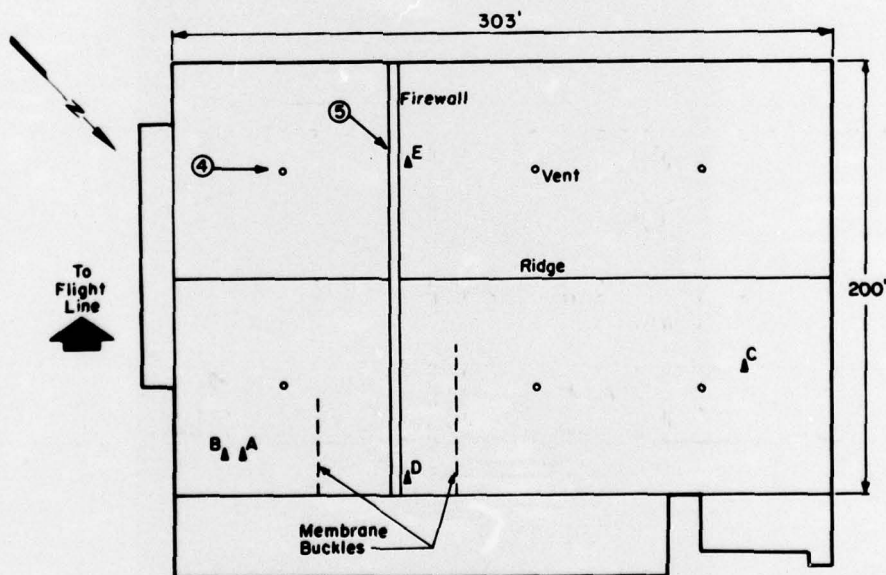
Figure 6. Plan view of roof of Building 116. The water content of the insulation at samples A, B and C (taken in Sept 1975) was essentially 0. Samples D and E were taken by WES in 1975. Sample D was dry, but some moisture was detected in sample E. Arrows indicate the viewing direction and location of subjects in Figures 4 and 5.

Building 116 was surveyed on two separate occasions: 10 September 1975 and 14 October 1976. A few faint anomalies were detected in 1975. They were sampled where shown in Figure 6. Each of samples A, B and C had a water content of 0%. Samples D and E were taken by WES in 1975. Sample D was dry, but a small amount of moisture was detected in sample E. The 1976 resurvey indicated that no new anomalies had developed since 1975.

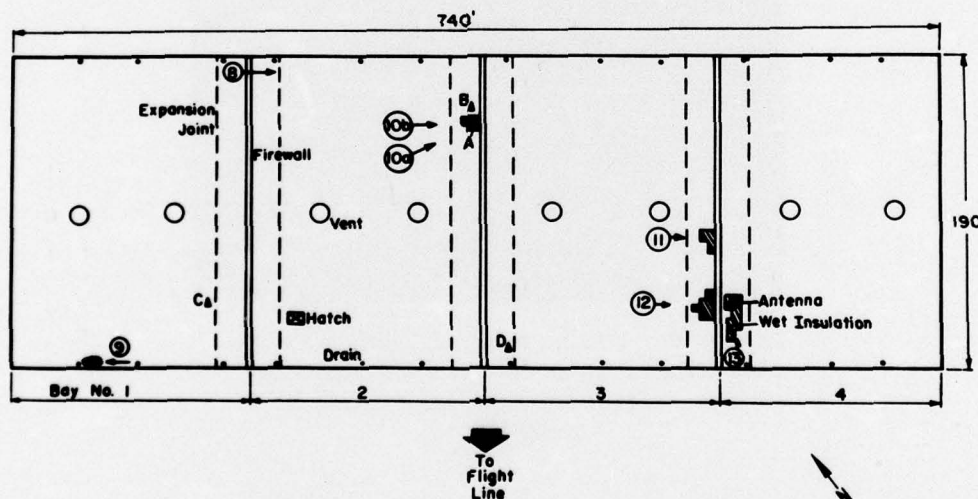
Figure 7. Plan view of Building 122. The insulation of samples A and B had water contents of 318% and 0%, respectively. Samples C and D, taken by WES in 1975, were both dry. The arrows point to the viewing direction and location of subjects in Figures 8-13. Wet areas have been outlined in white spray paint on the roof.

The overall thermal appearance of the roof when viewed with the infrared camera was good. However, five small moisture-caused anomalies were detected. They are cross-hatched on Figure 7. The perimeter of each anomaly was marked with white spray paint for future reference. The anomaly marked in bay 1 is shown in Figure 9. Water quite likely entered this area through a flaw in the membrane at the vent penetration or at the drain shown in Figure 9.

Flaws associated with the five wet areas on this roof should be repaired as soon as possible. Since the areas are small, the thermal implications of leaving the wet insulation in place are also small. If the roof membrane were not blistered it would be suggested that the five

The roof of *Building 122* contains five small wet areas. The penetrations and flashing flaws associated with each wet area should be repaired, but because of the age and condition of the roof, it does not seem necessary to remove the wet insulation and replace it with dry insulation and a new membrane in those small areas. Because the membrane is badly blistered, a new roof will probably be required within five years. However, since most of the insulation is dry and leaks are not a problem, it seems premature to replace all the insulation and the membrane at this time. Annual checks with the infrared camera are recommended.

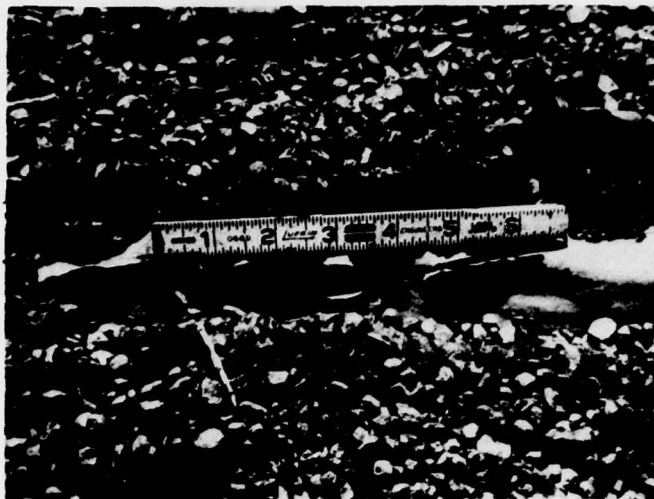
Figure 8. Crack in hammered-down expansion joint, bay 2, Building 122.

expansion joints and the outer two bays have one expansion joint, as shown in the figure. The roof consists of a gypsum deck, $1\frac{3}{4}$ -in. glass fiber insulation, and a $\frac{3}{8}$ -in.-thick gravel-coated built-up membrane. The membrane is badly blistered over the entire roof. Felt flashings at the firewall are dried and cracked. The ends of the metal expansion joints had been hammered down onto the roof to facilitate drainage of ponded water. At one such location a sizeable crack was present in the expansion joint (Fig. 8).

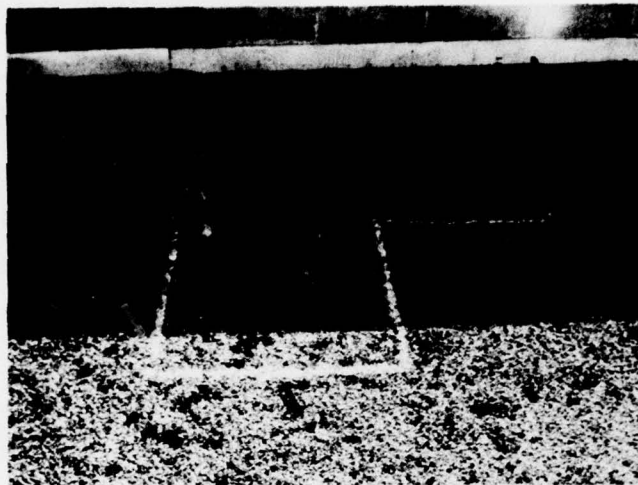
A conventional photograph and a thermogram of the anomaly in bay 2 are presented in Figure 10. Flaws in the firewall flashing are quite likely responsible for this problem. Similar flaws probably are also responsible for the two wet areas detected in bay 3 (Fig. 11 and 12). Samples A and B were taken inside and outside of the bay 2 anomaly to verify that wet insulation was present. The insulation outside the anomaly was dry (water content 0%). Within the anomaly a water content of 318% was measured. Samples C and D were taken by WES as shown in Figure 7. They were both dry. A photograph and thermogram of the bay 4 anomaly are presented in Figure 13. The wet area was located at a TV antenna at the base of which a hole had been drilled through the roof to permit access for the antenna wire.

Figure 11. One of two spray-painted anomalies in bay 3, Building 122.

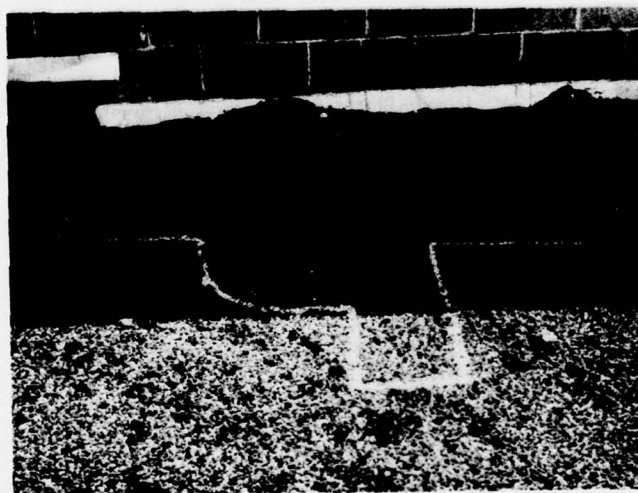
Figure 12. Second spray-painted anomaly in bay 3, Building 122.

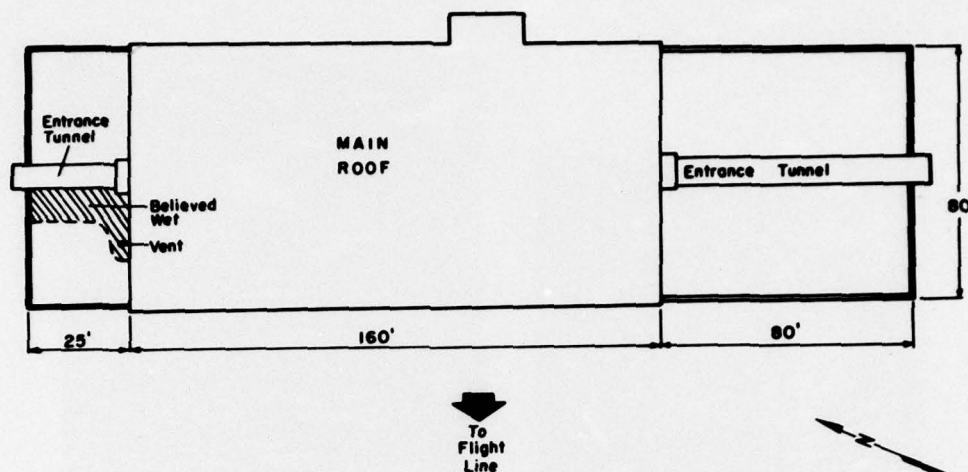
Several anomalies were detected with the infrared camera. All but one were traced to mounds of gravel up to 3 in. deep on the roof. The one anomaly not associated with a gravel mound was on the northwest low roof. Although no samples were permitted on this roof, there can be reasonable confidence that the area cross-hatched in Figure 14 contains wet insulation. However, insulation in the cross-hatched area in Figure 14 should be sampled to verify the infrared findings. Since the wet area is quite large, it is suggested that the membrane and insulation be removed and replaced over the entire northwest low roof.

Figure 14. Plan view of Building 205. The main roof is one story high while the four side roofs are about 2 ft below ground level. They are separated from the ground by a perimeter wall which projects a few inches above grade.

The other three low roofs of this building have some perimeter flashing problems which should be resolved to prevent these roofs from suffering the same fate as the northwest low roof.

A large portion of the northwest low roof of *Building 205* is expected to contain wet insulation. Replacement of the northwest low roof seems justified. However, a sample should be taken there before contracting for replacement of the insulation and membrane to verify infrared findings. Perimeter flashings and other penetrations should be comprehensively repaired on the other three low roofs.
